NATIONAL DAM INSPECTION PROGRAM. SILVER STREAM RESERVOIR DAM (I--ETC(U)

REPORT DOCUMENTATION PAGE		READ INSTRUCTIONS BEFORE COMPLETING FORM
1. REPORT NUMBER	2. GOVT ACCESSION NO.	3. RECIPIENT'S CAT. LOG NUMBER
	AD A109900	
4. TITLE (and Subtitle) Phase I Inspection Report Silver Stream Reservoir Lower Hudson River Basin, Orange County, NY Inventory No. 511		5. TYPE OF REPORT & PERIOD COVERED Phase I Inspection Report National Dam Safety Program

**SILVER STREAM  
RESERVOIR DAM  
NY 00511**

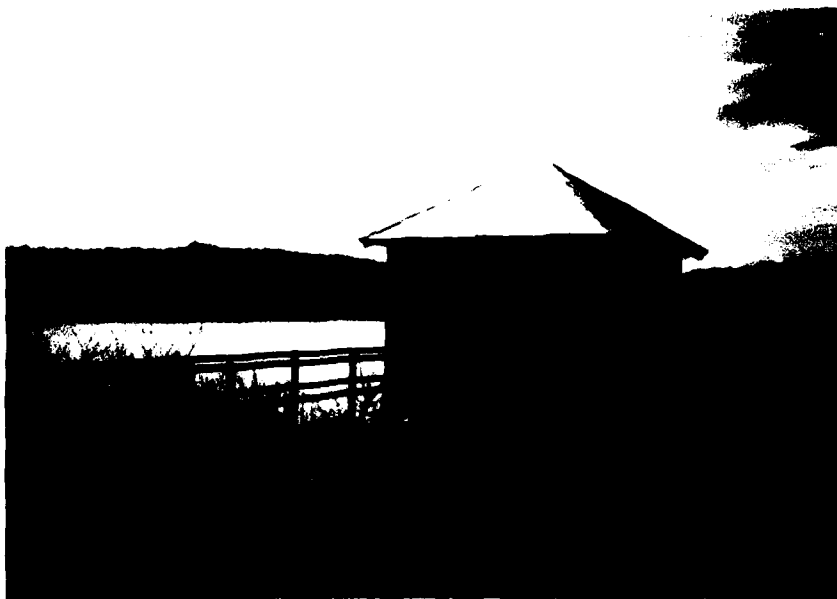
The dam has a concrete intake structure and control tower on the upstream side. On top of the control tower there is a brick gate house with a slate-shingled roof (see Photo A-5A). The intake structure and the majority of the control tower were submerged and unobservable. The gate house and exposed portion of the control tower were inspected and are in good condition.

A-5A Control tower with gate house and service bridge - 4/9/81

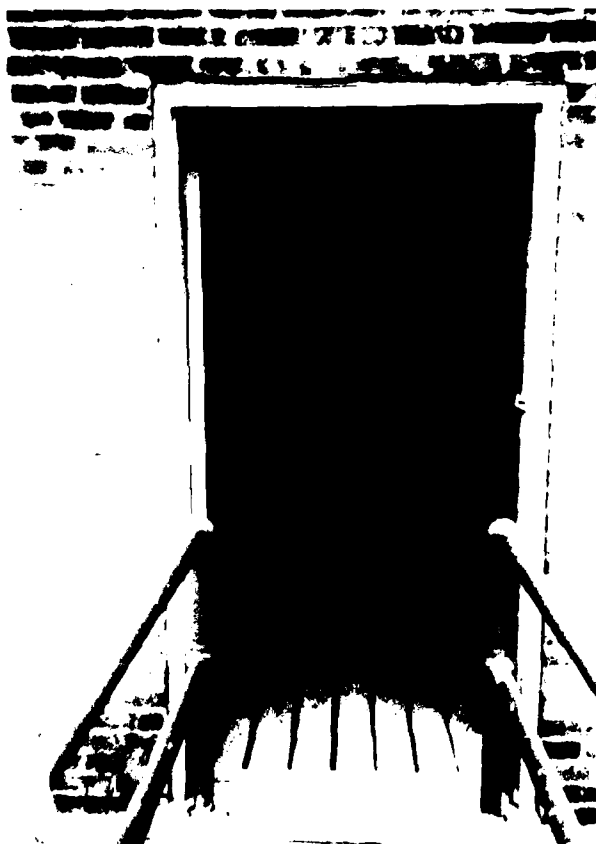
Inside the gate house there is a double hand crank bevel geared floor stand (see Photo A-5B) for operating the gate valve on the outlet pipe. This mechanism was well lubricated, operable, and in very good condition. The gate of the valve itself, although rusted and leaking somewhat when closed, also appeared in good condition (see Photo A-6B).

A-5B Double hand crank bevel geared floor stand for valve on outlet pipe - 4/9/81

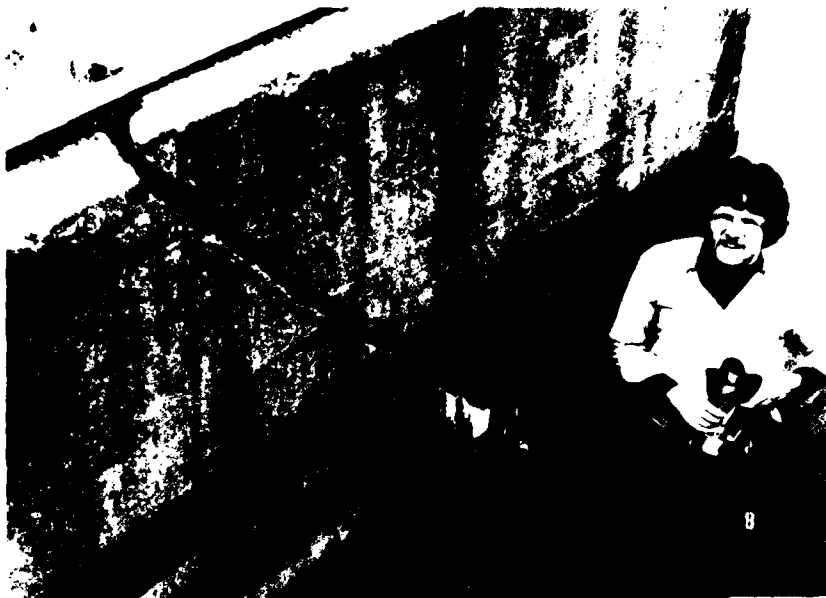
Also in the past, two steel bars were bolted to the left training wall of the outlet pipe discharge channel to prevent the further widening of a large crack. The date of this repair, which appears fairly old, is unknown.

A-7A Crack with steel strapping in left training wall of outlet pipe discharge channel - 4/9/81
